# **SAFETY LEVEL OF PEDESTRIAN IN URBAN AREA**

(Study Case: Residential area adjacent with official area)

**Prima Juanita Romadhona\*)**

Research and Development Unit, Ministry of Transportation

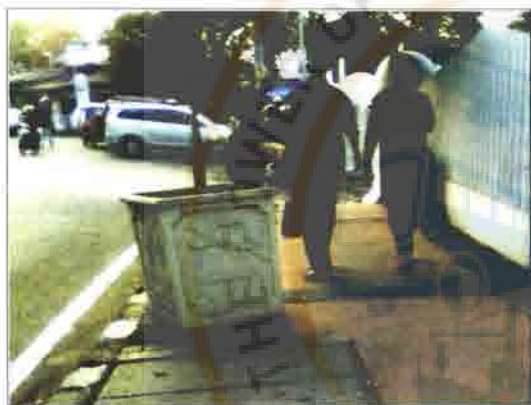
Figure 6. Pedestrians at Pejambon Street

Pedestrians volume at Pejambon Street is very busy in the morning. It can be seen in the picture beside that pedestrians along Pejambon Street is resident who live in Pejambon area and others who has activities around.

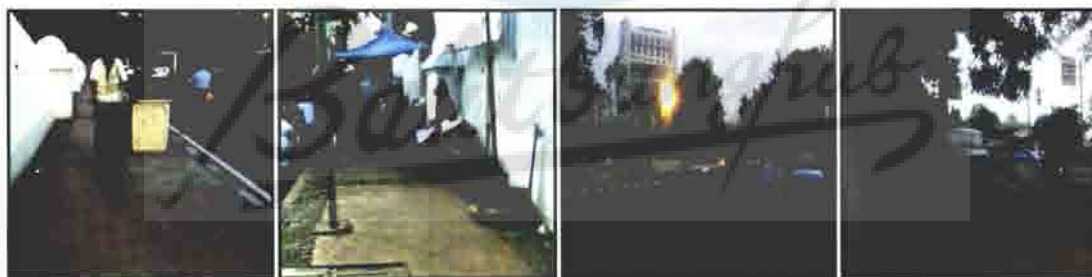
Figure 7. Violation that concerned on pedestrians safety and facilities at Jalan Pejambon

There are high numbers of pedestrians/hour which reach 364 pedestrians/hour. More than 80% of them do the activities in the south side. Unfortunately, this number does not noticed by government and other road user. It is proven by many violations as follows.

1. Motor vehicle park at the sidewalk;
2. No crossing facilities;
3. No crossing priorities;
4. No mark and sign for pedestrians;
5. Street vendor on the sidewalk.

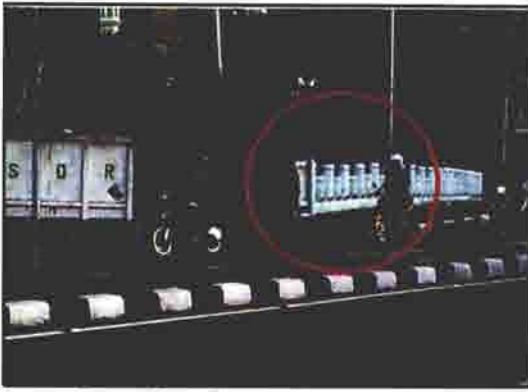
**Figure 10.** Pedestrian Conflict at Pejambon Street

From the figure 10 shows that the majority of conflicts between pedestrians occur with high-speed of motor vehicles. They do not care about the presence of pedestrians who cross along the way. As the result, many pedestrians were running when they cross describes pedestrians does not feel safe while crossing.

The picture beside is a serious conflict between pedestrians and motorcycles. There can be seen that the distance of conflict between them around 2 meters and motorcycle speed almost 40 km/h. There is an effort and evasive action from pedestrian with crossing the street by running.

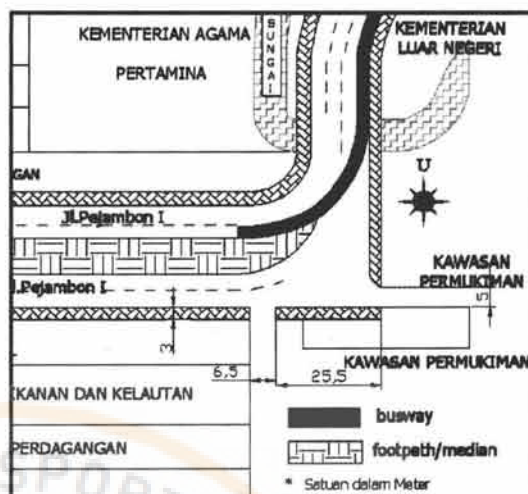
**Figure 15. Additional Sidewalk Width**

Base on Direktorat Bina Sistem Perkotaan, 2006<sup>7</sup> for residential area which adjacent with official area, minimum sidewalk width is 150-200 cm whereas the recommended width is 275-300 cm. However, it needs extra width in the region if any additional facilities such as light poles, traffic signs, or plant pot. Additional width required by the rules of Direktorat Binamarga<sup>8</sup> if the sidewalk contained light pole, the additional width is 75-120 cm and 150 cm for plant pot. Thus, safe width for sidewalks in urban area with additional facilities is 300-450 cm.

So that, the width that suggested for Pejambon Street is 350 cm.
